**Flood Control Project Maintenance  
Levee Inspections  
LMA District Cover Sheet  
Spring 2012 Levee Inspection Results**

**Reclamation District No. 0501 Ryer Island**

**Spring 2012 Levee Inspection Results**

Waterway	Bank	Unit Miles
Unit No. 01 Steamboat Slough	Right	6.76

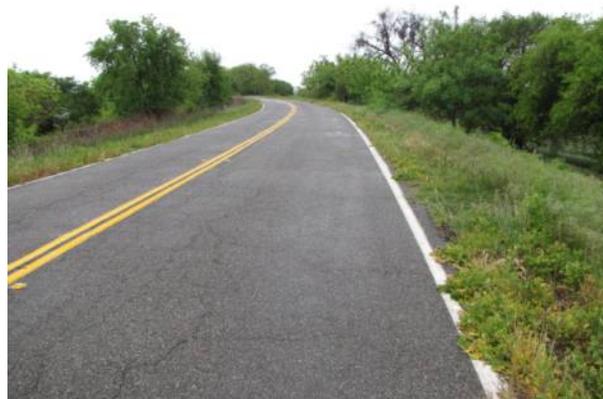
Levee Mile Report Line	4
Start Levee Mile	0.01
End Levee Mile	0.01
Location	Land Side
Category	Earthen Levee
Item	Vegetation
RD 501 Unit 1 Looking downstream from levee mile 0.00. Photo taken 4-25-2012.	
phillips_s_20120524_443.jpg

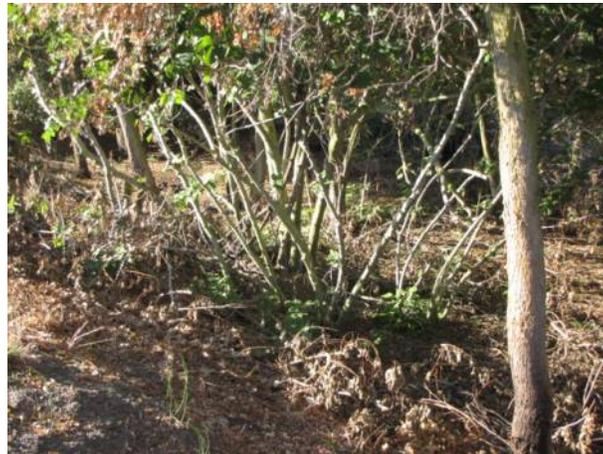
Levee Mile Report Line	8
Start Levee Mile	0.13
End Levee Mile	0.24
Location	Land Side
Category	Earthen Levee
Item	Trim / Thin Trees
Levee mile 0.13: District need to remove the fig trees from levee section on the land side, not trim them up like shown in this photo. All these shown here are less than 2-inches in diameter.	
phillips_s_20120306_138.jpg

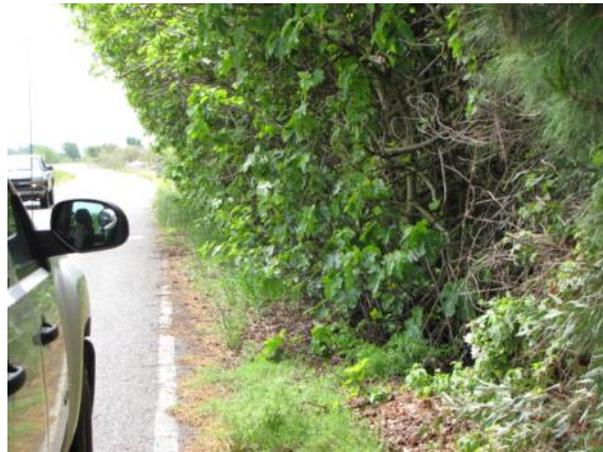
Levee Mile Report Line	10
Start Levee Mile	0.25
End Levee Mile	0.29
Location	Land Side
Category	Earthen Levee
Item	Vegetation
Looking downstream landward shoulder levee miles 0.25-0.29. Photo taken 4-25-2012.	
phillips_s_20120524_444.jpg

10	0.25	0.29	Earthen Levee	Vegetation	LS	U Ma	V2 : Remove the wild growth other than native grasses from the levee slopes.	38.250931 ° -121.603154 °	38.250429 ° -121.603086 °	45 Y
								DWR ID: DWR_RD0501_01_s_2012_45		
11	0.26	0.28	Earthen Levee	Trim / Thin Trees	LS	U Ma	T3 : Trim and thin trees to allow visibility of the ground and room to flood fight. Inspector Comments: There is a thick growth of fig trees that should be removed from levee section that blocks the view of the levee slope.	38.250927 ° -121.603107 °	38.250610 ° -121.603111 °	5 Y
								DWR ID: DWR_RD0501_01_s_2012_5		
12	0.30	0.35	Earthen Levee	Vegetation	LS	M Ma	V2 : Remove the wild growth other than native grasses from the levee slopes.	38.250261 ° -121.603126 °	38.249562 ° -121.603105 °	6
								DWR ID: DWR_RD0501_01_s_2012_6

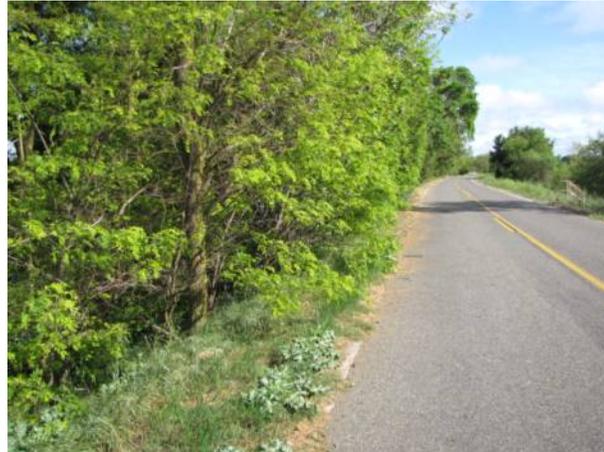
Levee Mile Report Line	11
Start Levee Mile	0.26
End Levee Mile	0.28
Location	Land Side
Category	Earthen Levee
Item	Trim / Thin Trees
<p>New photo of unsatisfactory tree growth on levee miles 0.26-0.28 looking upstream from the landside shoulder. Photo taken 4-19-11.</p>	
<p>phillips_s_20120306_140.jpg</p>

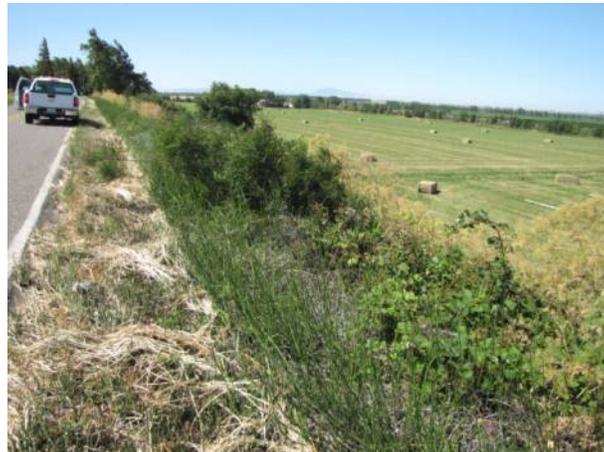
Levee Mile Report Line	20
Start Levee Mile	0.75
End Levee Mile	0.94
Location	Land Side
Category	Earthen Levee
Item	Vegetation
<p>The berries here completely block the view of the levee section. Standing at levee mile 0.75 looking downstream to levee mile 0.94. Photo taken 11-03-2010</p>	
<p>phillips_s_20120306_141.jpg</p>

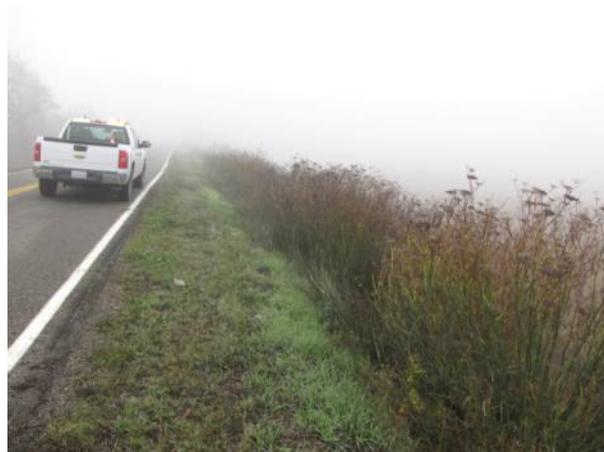
Levee Mile Report Line	20
Start Levee Mile	0.75
End Levee Mile	0.94
Location	Land Side
Category	Earthen Levee
Item	Vegetation
<p>New photo for levee mile 0.75-0.94 RD 501 Unit 1. Photo taken 11-29-2011.</p>	
<p>phillips_s_20120306_142.jpg</p>

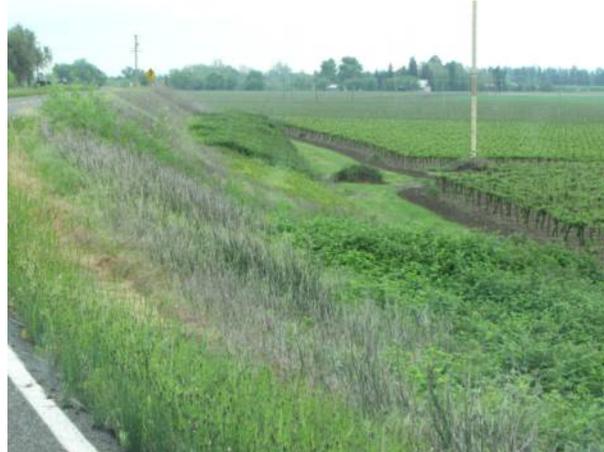
Levee Mile Report Line	24
Start Levee Mile	1.55
End Levee Mile	1.74
Location	Land Side
Category	Earthen Levee
Item	Vegetation
Looking downstream landside slope and toe , unsatisfactory growth. Photo taken 4-25-2012.	
phillips_s_20120524_445.jpg

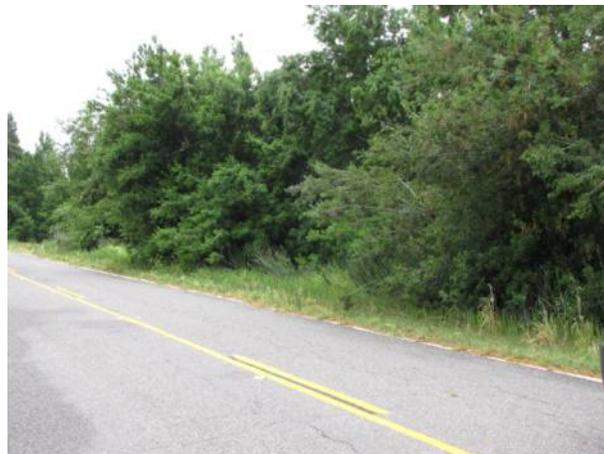
Levee Mile Report Line	39
Start Levee Mile	3.48
End Levee Mile	3.48
Location	Land Side
Category	Earthen Levee
Item	Vegetation
<p>Looking downstream from levee mile 3.27. Photo taken 4-25-2012.</p> <p>phillips_s_20120524_447.jpg</p>

DWR ID: DWR_RD0501_01_s_2012_43										
39	3.48	3.48	Earthen Levee	Vegetation	LS	U Ma	V2 : Remove the wild growth other than native grasses from the levee slopes.	38.206744 ° -121.612162 °	38.206742 ° -121.612164 °	54 Y
DWR ID: DWR_RD0501_01_s_2012_54										
40	3.55	5.08	Earthen Levee	Vegetation	LS	M Ma	V2 : Remove the wild growth other than native grasses from the levee slopes.	38.205654 ° -121.612549 °	38.194993 ° -121.631661 °	28
DWR ID: DWR_RD0501_01_s_2012_28

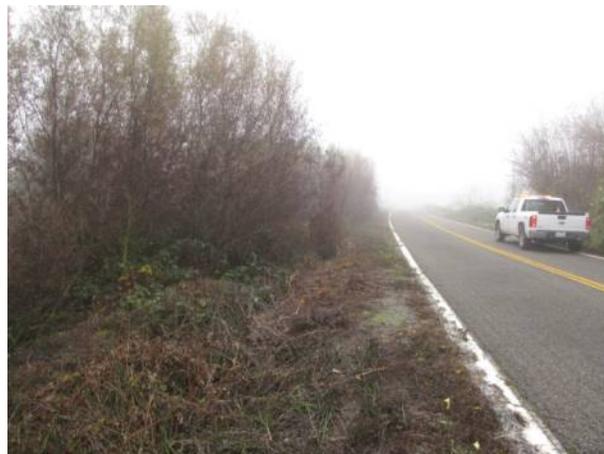
Levee Mile Report Line	47
Start Levee Mile	3.79
End Levee Mile	3.94
Location	Water Side
Category	Earthen Levee
Item	Vegetation
<p>Unsatisfactory growth on waterside levee section levee mile 3.79-3.94. Photo taken 11-29-2011.</p> <p>phillips_s_20120306_154.jpg</p>

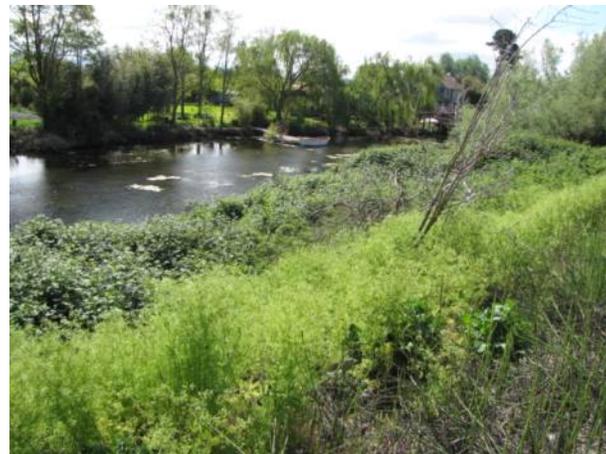
Levee Mile Report Line	49
Start Levee Mile	4.00
End Levee Mile	4.07
Location	Water Side
Category	Earthen Levee
Item	Vegetation
Looking downstream at waterside unsatisfactory growth on the levee slope. No change from fall inspection. Photo taken 4-19-11.	
phillips_s_20120306_144.jpg

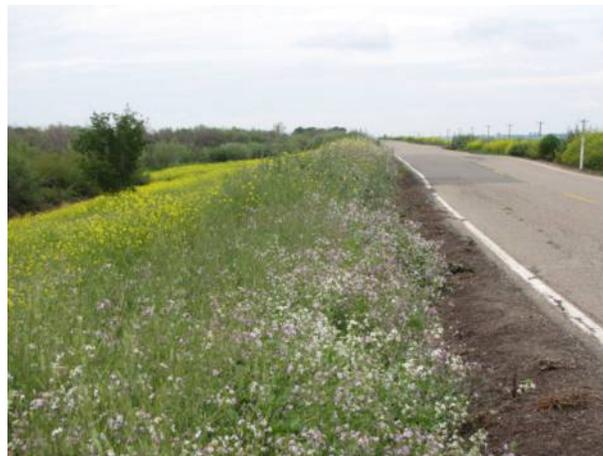
Levee Mile Report Line	4
Start Levee Mile	0.10
End Levee Mile	0.79
Location	Water Side
Category	Earthen Levee
Item	Vegetation
Looking downstream from waterside slope. Photo taken 4-25-2012	
phillips_s_20120524_455.jpg

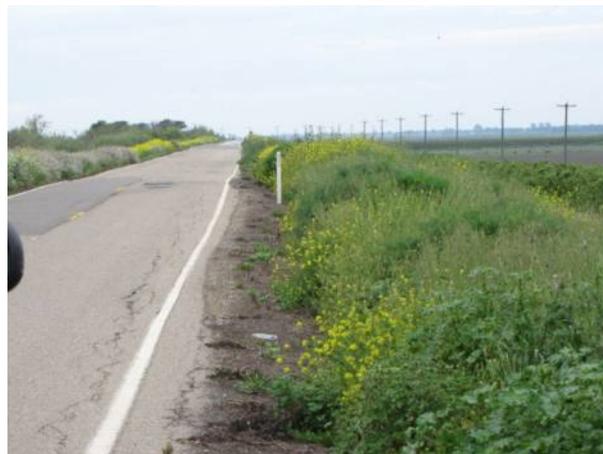
Levee Mile Report Line	5
Start Levee Mile	0.10
End Levee Mile	0.64
Location	Land Side
Category	Earthen Levee
Item	Vegetation
Looking downstream landward levee mile 0.01. Photo taken 4-25-2012.	
phillips_s_20120524_451.jpg

DWR ID: DWR_RD0501_03_s_2012_12										
5	0.10	0.64	Earthen Levee	Vegetation	LS Ma	U	V2 : Remove the wild growth other than native grasses from the levee slopes.	38.229065 ° -121.672201 °	38.229063 ° -121.672203 °	11 Y
DWR ID: DWR_RD0501_03_s_2012_11										
6	1.01	1.12	Earthen Levee	Cracking	CR Ma	M	CR1 : Monitor and have inspected by geotechnical engineer.	38.240026 ° -121.664694 °	38.241008 ° -121.663361 °	13 Y
DWR ID: DWR_RD0501_03_s_2012_13										
7	1.21	1.46	Earthen Levee	Cracking	CR Ma	M	CR2 : Schedule repair of subsidence prior to the next inspection.	38.241850 ° -121.661958 °	38.243607 ° -121.658435 °	14 Y
DWR ID: DWR_RD0501_03_s_2012_14										
8	1.57	1.57	Earthen Levee	Vegetation	LS Ma	M	V2 : Remove the wild growth other than native grasses from the levee slopes.	38.246660 ° -121.688600 °	38.666000 ° -121.690000 °	43 Y
DWR ID: DWR_RD0501_03_s_2012_43										
9	1.65	1.73	Earthen Levee	Vegetation	LS Ma	M	V2 : Remove the wild growth other than native grasses from the levee slopes.	38.206996 ° -121.655952 °	38.208065 ° -121.655999 °	7 Y

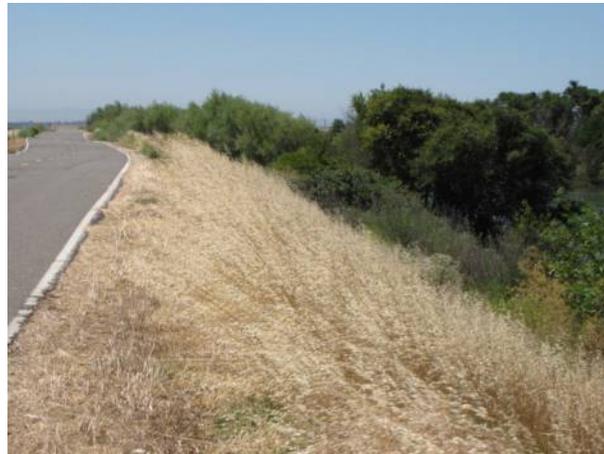
Levee Mile Report Line	12
Start Levee Mile	2.65
End Levee Mile	2.77
Location	Water Side
Category	Earthen Levee
Item	Trim / Thin Trees
Looking upstream from levee mile 2.77.	
phillips_s_20120306_181.jpg

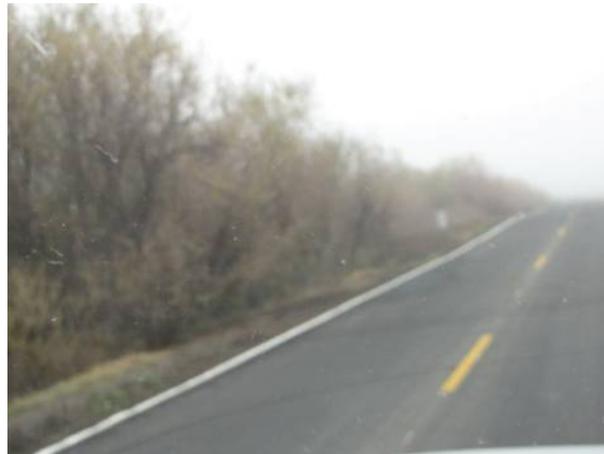
Levee Mile Report Line	13
Start Levee Mile	2.66
End Levee Mile	2.78
Location	Water Side
Category	Earthen Levee
Item	Vegetation
RD 501 Unit 3 levee mile 2.66-2.78 waterside looking downstream. Photo taken 11-29-2011.	
phillips_s_20120306_175.jpg

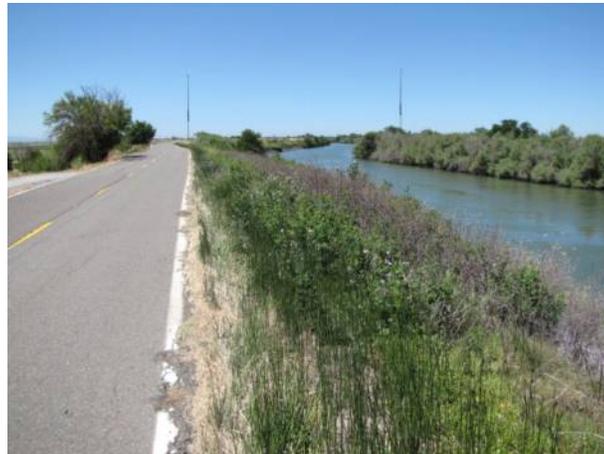
Levee Mile Report Line	14
Start Levee Mile	3.52
End Levee Mile	3.55
Location	Water Side
Category	Earthen Levee
Item	Trim / Thin Trees
Levee mile 3.52 standing on waterside looking upstream wild growth. Photo taken 11-03-2010	
phillips_s_20120306_183.jpg

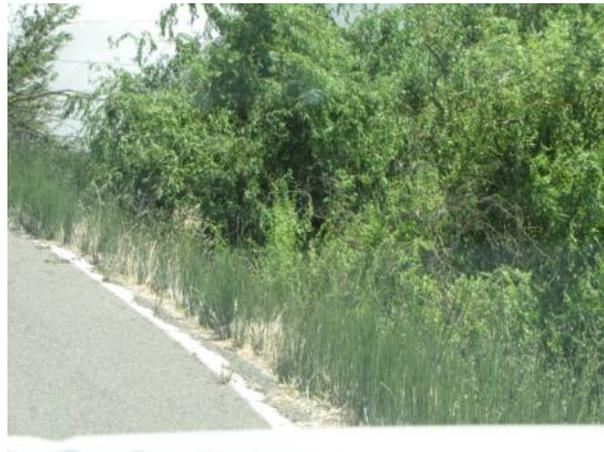
Levee Mile Report Line	14
Start Levee Mile	3.52
End Levee Mile	3.55
Location	Water Side
Category	Earthen Levee
Item	Trim / Thin Trees
Levee mile 3.55 land side tree growth on slope, you can't see the slope for wild growth. These trees has not been trimmed. Photo taken 11-03-2010	
phillips_s_20120306_184.jpg

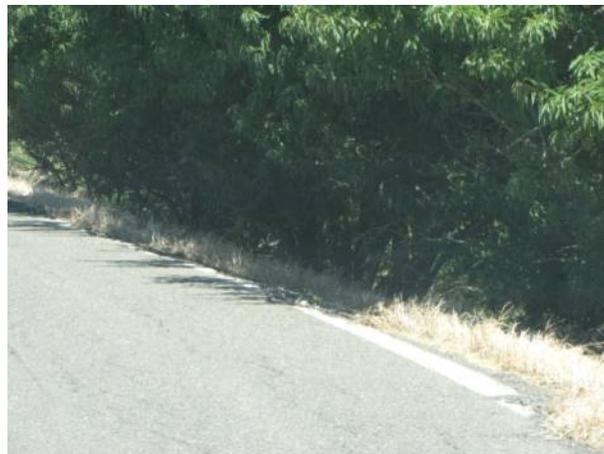
Levee Mile Report Line	18
Start Levee Mile	3.69
End Levee Mile	3.70
Location	Land Side
Category	Earthen Levee
Item	Trim / Thin Trees
Levee mile 3.69 tree growth has blocked view of levee on the land side.	
phillips_s_20120306_186.jpg

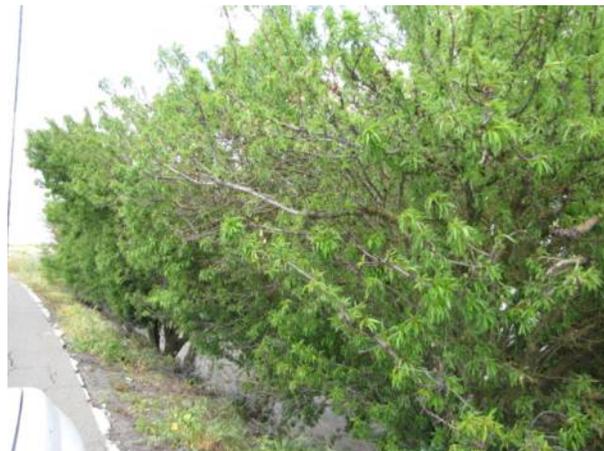
Levee Mile Report Line	18
Start Levee Mile	3.69
End Levee Mile	3.70
Location	Land Side
Category	Earthen Levee
Item	Trim / Thin Trees
Levee mile 3.69 to 3.70 new photo of the unsatisfactory growth on the landside levee slope. Photo taken 4-19-11.	
phillips_s_20120306_188.jpg

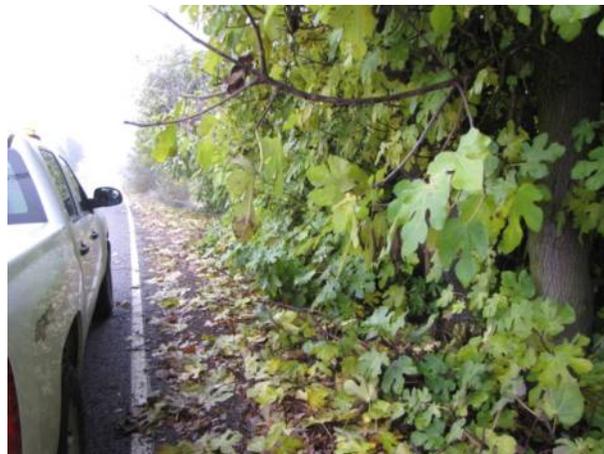
Levee Mile Report Line	11
Start Levee Mile	1.84
End Levee Mile	1.87
Location	Land Side
Category	Earthen Levee
Item	Trim / Thin Trees
RD 501 Unit 4 levee mile 184-1.87 looking downstream landside. Photo taken 11-29-2011.	
phillips_s_20120306_198.jpg

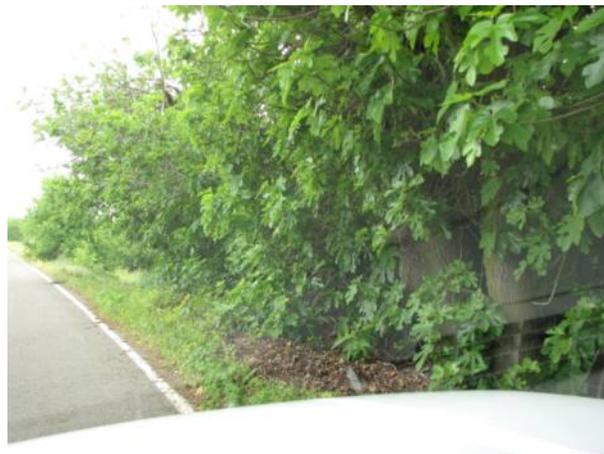
Levee Mile Report Line	11
Start Levee Mile	1.84
End Levee Mile	1.87
Location	Land Side
Category	Earthen Levee
Item	Trim / Thin Trees
Levee mile 1.84-1.87. Photo taken 4-25-2012.	
phillips_s_20120524_457.jpg

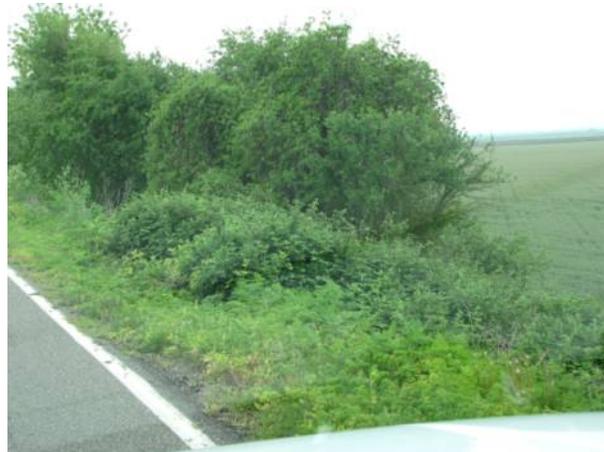
Levee Mile Report Line	15
Start Levee Mile	2.21
End Levee Mile	2.32
Location	Land Side
Category	Earthen Levee
Item	Vegetation
Levee mile 2.21-2.32 landward overgrown slope and toe. Can't see the levee for the wild growth. Photo taken 4-25-2012.	
phillips_s_20120524_459.jpg
